2014 Engineer's Annual Report

**Hypoluxo / Haverhill
Community Development District**

December 2014

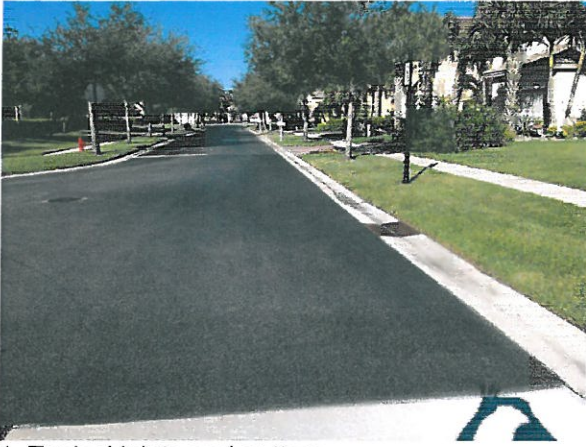
The drainage system in the "Coco Plum" development appears to be functioning properly. The street gutters and inlets, including the control structure leading to the L-17 canal, are clear of debris. The lake banks are stable with minor erosion at the water edge.

1. Typical inlets and gutters.

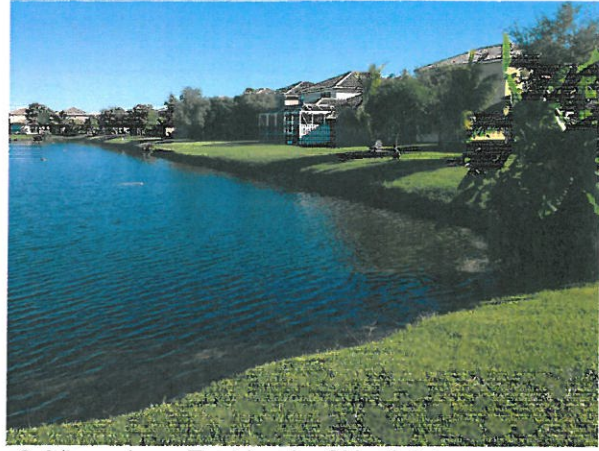
2. View along East bank of North lake.

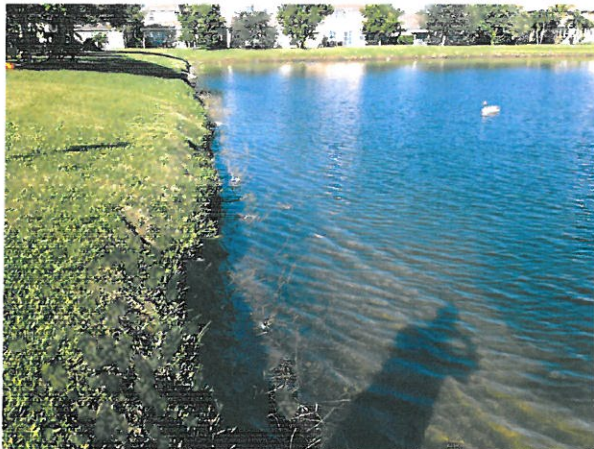
3. View Westward along South bank of North lake.

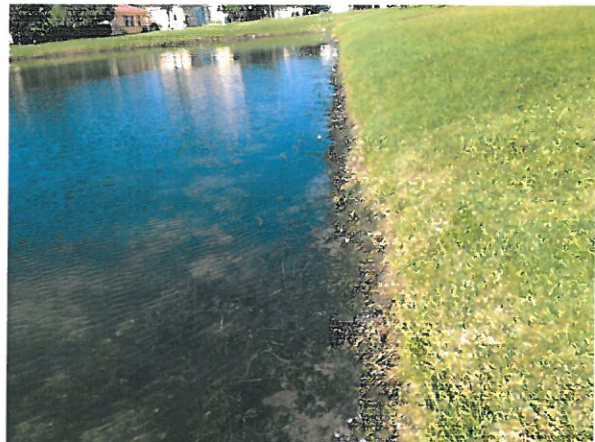
4. View Westward along North bank of North lake.

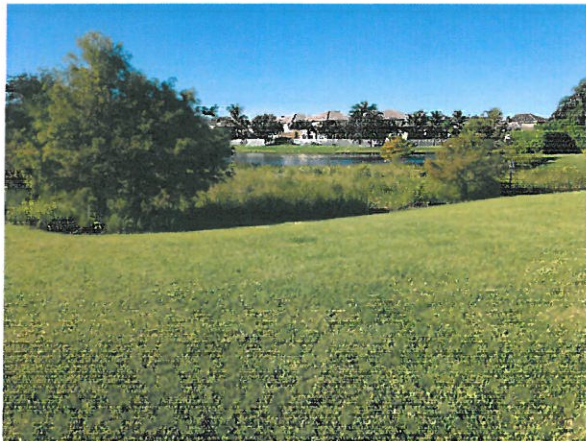
5. Littoral planting zone, NE corner of South Lake.

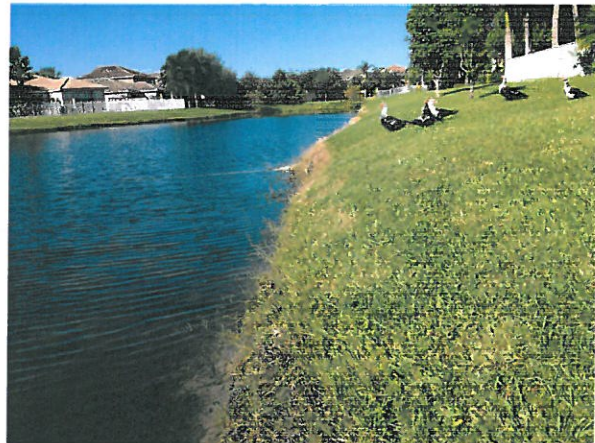
6. View Westward along Northern bank of South lake.

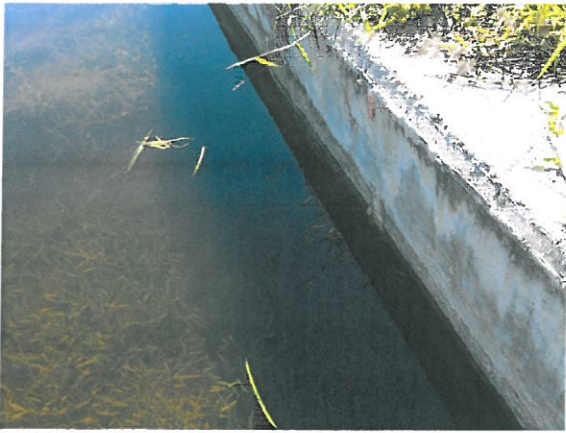
I also attached a photo of the location where the outfall pipe enters the L-17 canal. Silt and weed growth is blocking the lower 2/3 of the pipe diameter.

7. LWDD L-17 Canal bottom silt and weed at outfall pipe. (Outfall pipe in headwall obscured)

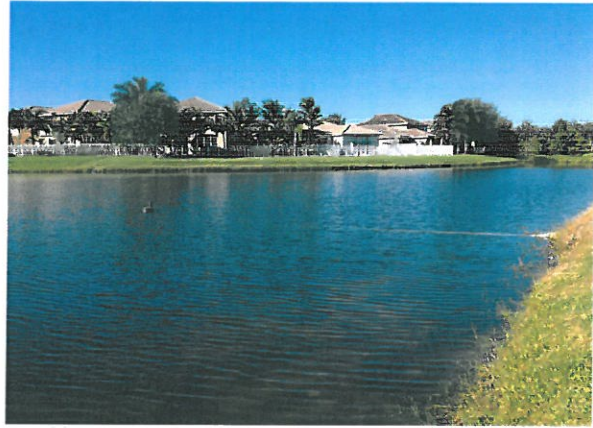
8. View Westward from SE corner of South lake.

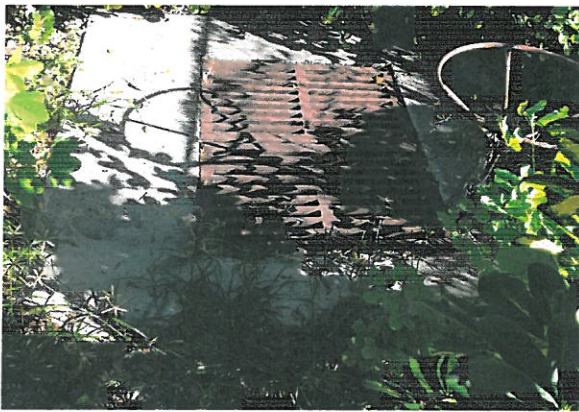
8. Grate on control structure at Northern boundary (South of L-17 canal).
